# Manhole Inspection Summary

Manhole # **S37CC\_056MH**

Insp Date: **1/17/08 10:32 AM**

**Location** Address: **616 EAGER ST**

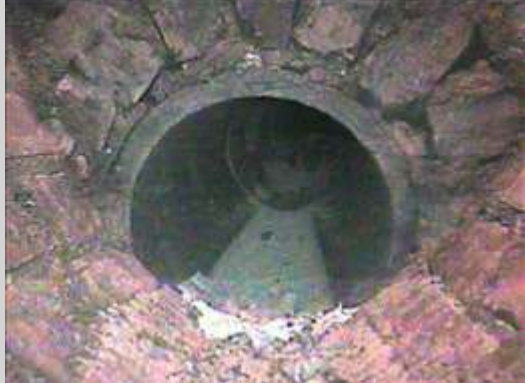
12 O'Clock Outflow

8 in. Circular Gravity Sewer  
Pipe Out @ 12 O'Clock

Pipe Material: **Clay** ☐ Pipe Lined

Invert Depth: **7.71** (ft.) Flow Characteristics: **None**

Deposits: ☒ None ☐ Mud ☐ Sludge ☐ Debris ☐ Grease

Infiltration: **None** Pipe Seal Cond: **Sound**
